PART 2 OF 3

March 7, 2006

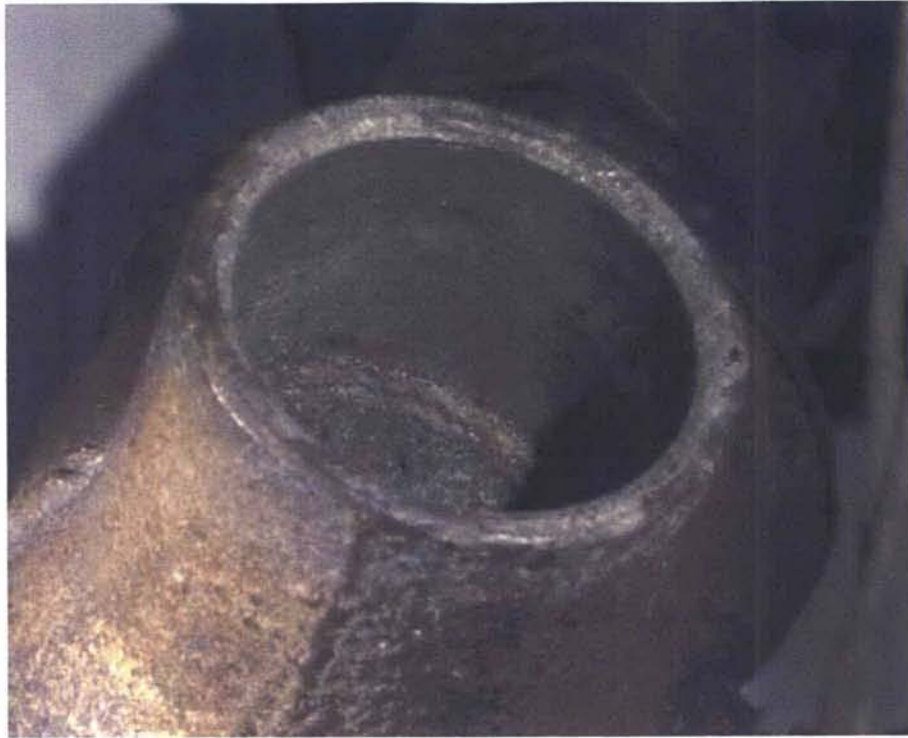
Figure 16. Stereomicroscope image of Joint Section 2.
